National Register of Historic Places Inventory—Nomination Form

7,000	- ++b			
1. Nan	1e			
historic	East Linden			
and or common				
2. Loca	ation			,
street & number	979 Cox Neck I	ane		not for publication
city, town	Red Lion Hundred	_X_ vicinity of	St. Georges	
state	Delaware cod	e county	New Castle	code

East Linden

A EAST LINDEN (N-5044)

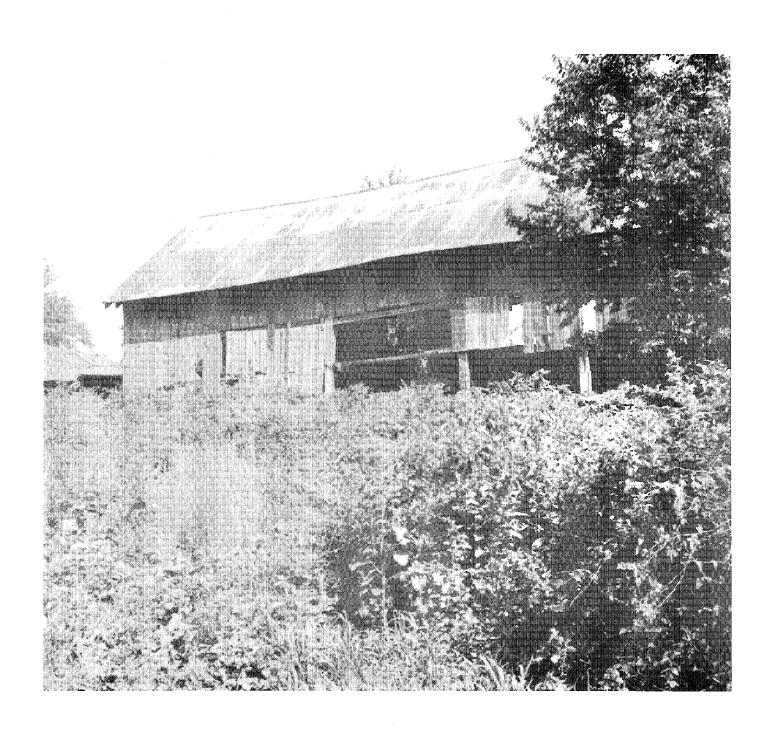
The outbuildings to this cottage generally are in poor to deteriorated condition. Nearing collapse is a 2-story frame barn with corrugated metal roof that appears to be contemporaneous with the house; the barn has a side open sheltered enclosure. Other outbuildings include a two-port frame car barn, two frame sheds, and a dairy of concrete masonry unit construction.

Fig. 2-4. East Linden (N-5044), Barn, south elevation.
